# The Prospectus

April 2019

## The Trials and Tribulations of a Baldwin Owner

### by Mike Manners

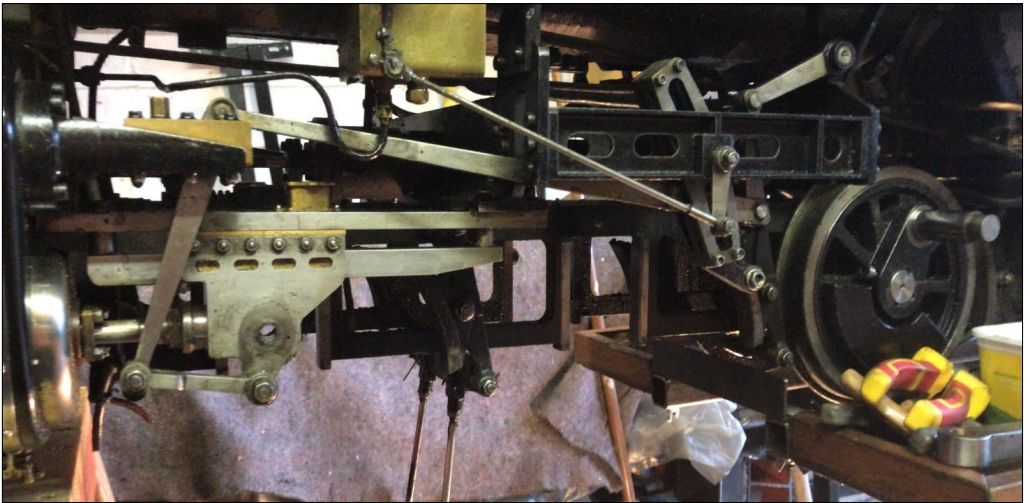
Baldwin with two axles missing

The first job was to get the engine securely supported and drop out all of the wheels and axles. The next bit looked rather brutal but was the only way to proceed. The axles were cut in half. It was the only way they could be mounted on the hydraulic press to remove the axles from the wheels. Putting the wheel sets in the band saw looked dramatic but was the quickest way to proceed. Then came the tricky job of

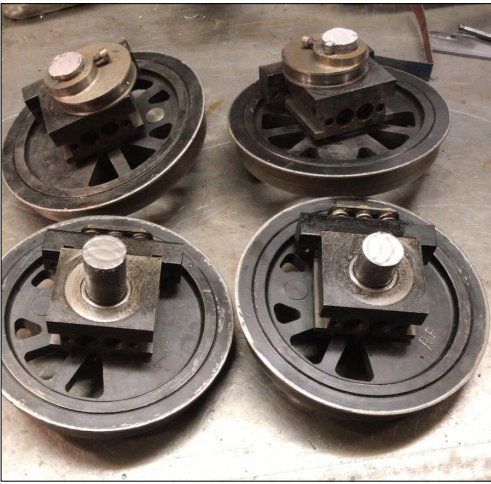
*Above* Axles cut in half

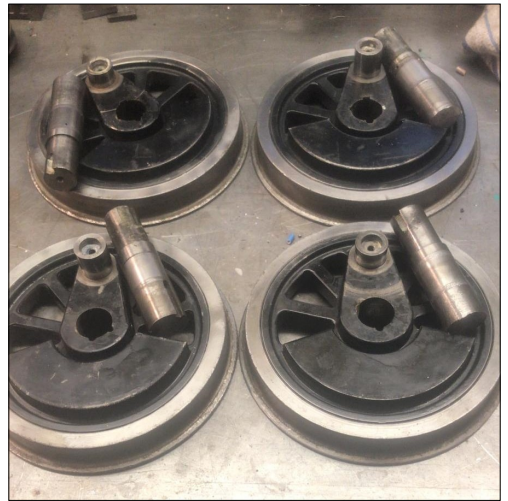
*Right* Axles pressed out

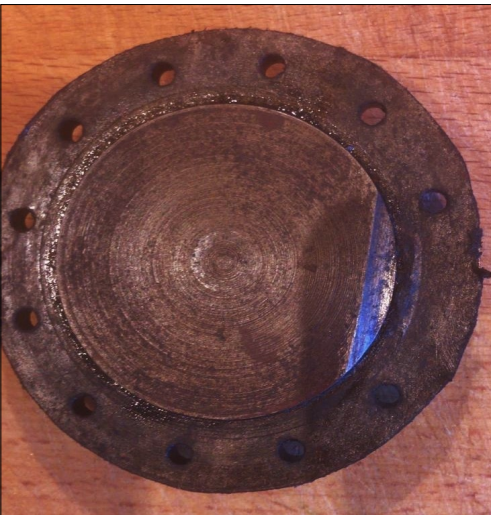
An inspection of the inside of one of the end covers showed a very slight mark in the centre of the cover. It was just possible to make out a hexagon shape. The only way this mark could have been made was by the nut that retained the piston on the piston rod impacting the end cover. It was just possible that the cause of the knocking noise had been found. The next question was why had this started to happen? The noise had not always been there. It was something that had developed over the last 12 months or so. The only reason I could think of was that the significant wear in the axle and other bearings was allowing the piston to travel further up and down the cylinder than it was designed to do. Now that the various bearings had been replaced the piston would be restrained in its travel and the knock would probably be gone.

*Below* Cylinder end cover with impact mark

Just for good measure Nigel reduced the thickness of the nut and increased the thickness of the end cover sealing gasket.

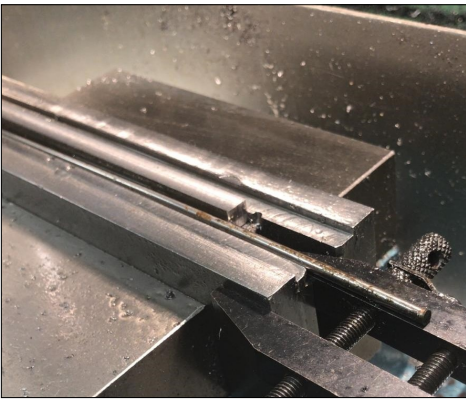
*Left* Key ready for machining

It was then on to making the four keys. Another job requiring some very careful machining, filing and fitting. Next it was then back to the hydraulic press to fit the wheels back on the new axles making sure all the appropriate axle boxes and eccentrics were in place. The actual job of pressing the wheels onto the axles went very well. As it turned out a little too well. A Baldwin wheel set is relatively heavy so putting them back onto the locomotive is not easy. Its almost impossible to support the weight and fiddle the axle boxes into the guides. In the end we came up with a system of bungee straps over a ladder suspended from the workshop ceiling to support most of the weight. The job then became so much easier.

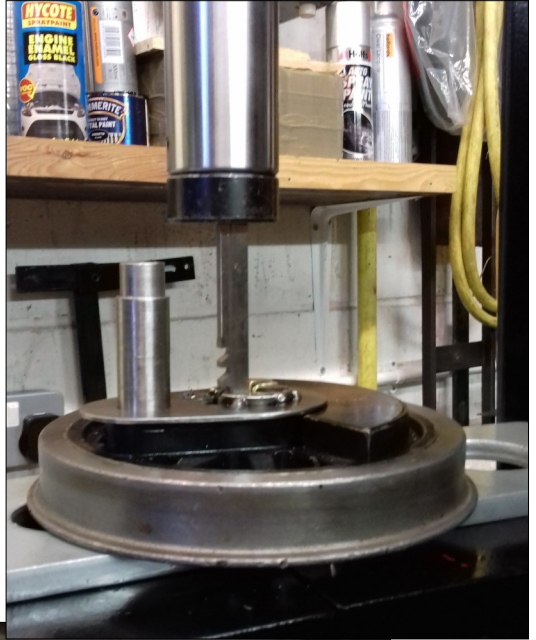
*Right* Wheel broaching

The next step was back to the hydraulic press to broach keyways in the four wheels. Nigel had made a broaching guide that he had used on the previous wheel set to ensure the keyways were all in the correct location.

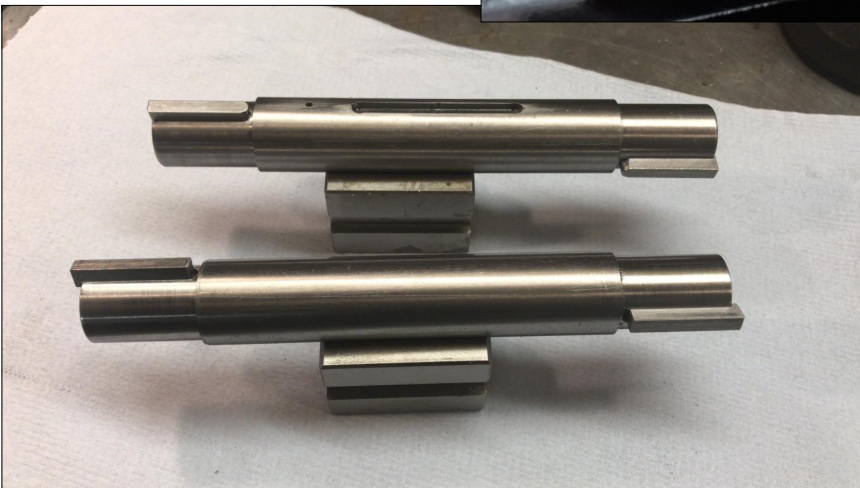
*Below* Two new axles ready for wheel fitting

making new axles. They would be a press fit in the wheels and held in with keys and Loctite just for good measure. Making the new axles was time consuming and exacting work as each axle end had to be individually match to the appropriate wheel and sized to achieve the appropriate press fit. The axles then had to have the keyways machined being very careful to ensure the 90 degree quartering was maintained and that the appropriate wheel was leading.

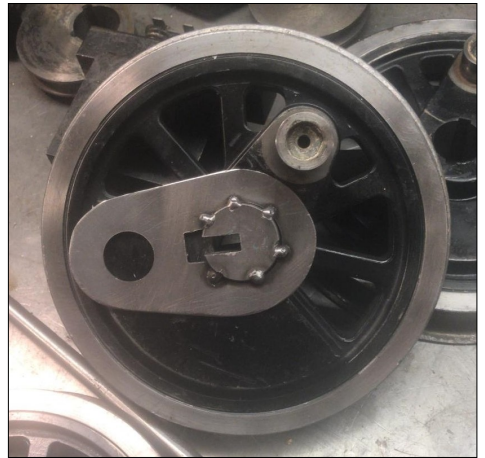
*Right* Wheel broaching guide

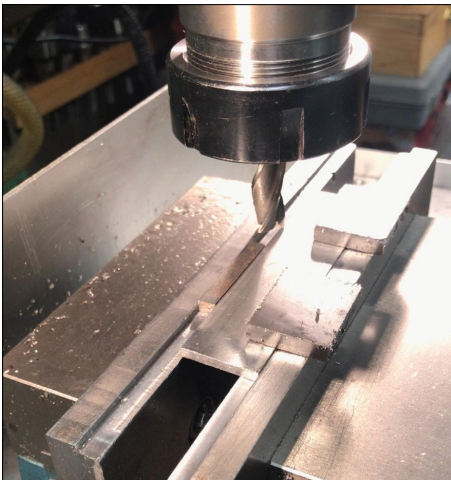
*Left* Stepped key being machined - not easy to hold!

After some discussion and further measurements Nigel pressed off the offending wheel. It was agreed that the only real solution was to manufacture a stepped key and press the wheel back on with the stepped key inserted. I used AutoCad to produce an accurate full size drawing from the measurements previously taken. This allowed us to work out the exact size and shape of the stepped key and produce a ten times full size drawing. Nigel then had the very tricky job of making the key. A stepped key of the size required is not only tricky to machine but also very difficult to hold in the machine vice. To cut a long story short, the key was produced and the wheel pressed back on the axle. This time the coupling rods went back with a lot less trouble, the
