Reading Society of Model  
Engineers  
www.prospectpark  
railway.co.uk  
Charity Number 1163244

# The Prospectus

November 2018

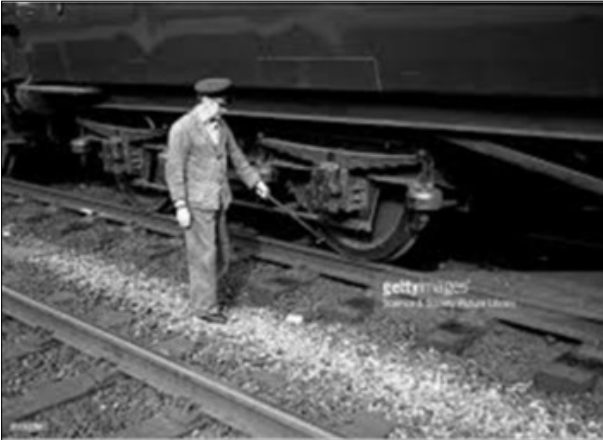
In 1998 the worst accident on German Railways occurred at a town called Eschede when a high speed train derailed and hit a bridge killing 101 people and injuring another 100. The cause was a single fatigue crack in a wheel. Nowadays wheel blanks are hydraulically forged and much, much less prone to cracking.

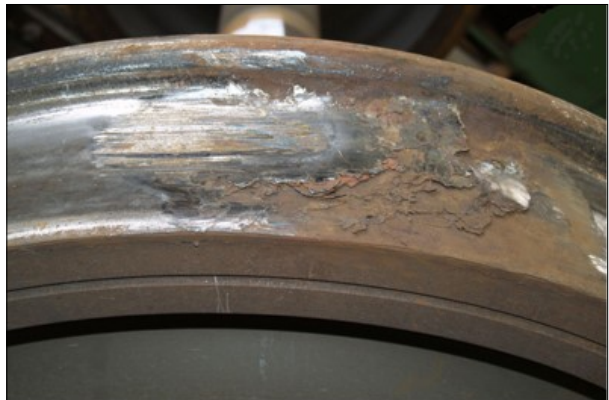
The next figure shows the extremes of wheel tread and wheel flange wear compared with the profile of a new wheel. I discussed in an earlier part of this series how the coning effect of an appropriately profiled

wheel rim and rail results in an inherent self-centring and aligning effect. It's not difficult to envisage that as the rim wears hollow this effect is lost. In fact in this extreme example the single point of rail wheel rim contact becomes two, against which the wheel can oscillate.

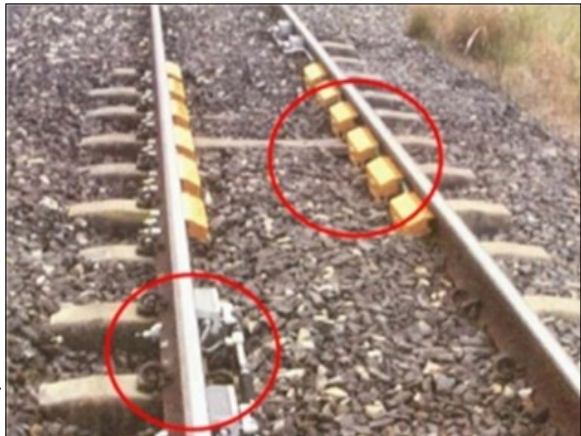
Just as in the case of the rail, regular monitoring of wheelsets takes place as part of routine maintenance and inspection. Obvious damage to wheel rims and flanges can be detected using cameras which operate when the train is under motion. There are also laser systems which can be rail-mounted and measure profiles to an accuracy of 0.5mm on a train running at 150 kph (93 mph).

Ultrasonics are used to check for the unlikely event of a wheel crack and there even devices which can measure wheel diameter, out-of-roundness, flange height and back-to-back distance.

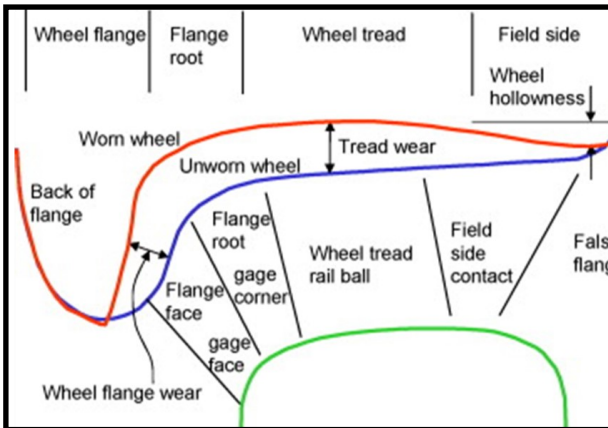
As one would expect unless a wheel has gone beyond its useful life it is possible to re-profile. In some cases this can be done without removing the wheel set in what is

sometimes called an Underfloor Truing Machine. This involves rotating the wheel slowly on a rolling bed and grinding the profile. Typically for this method the amount of material to be removed is relatively small, 1 to 2mm. For new wheel forgings and the badly worn the traditional wheel lathe is used. I say traditional but modern wheel lathes are to a large extent fully automated and modern cutting technology is used. So to conclude, I show a simplified representation of a modern wheel lathe together with something familiar to many people in RSME, the carbide tip! See next page—Ed.

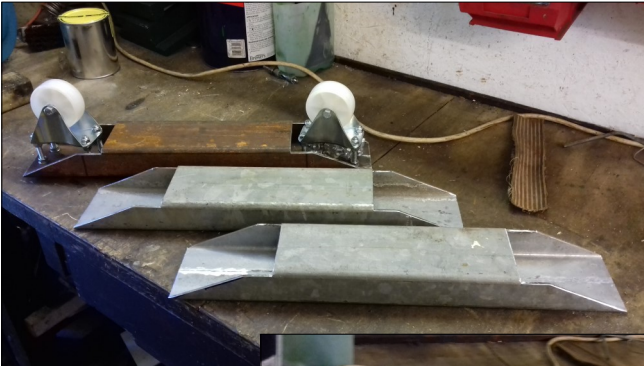
Pictures of the raised track extension point construction going on. These are the wheel beams that support the track

beam and allow it

....to be rolled into position.

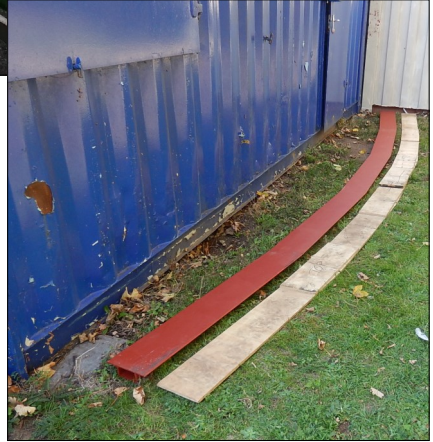
This is the long steel beam that will support the track for the new point in the woods laying alongside the template used in its manufacture. As you can see, its quite a long structure. Almost the full length on the blue 20 foot container.

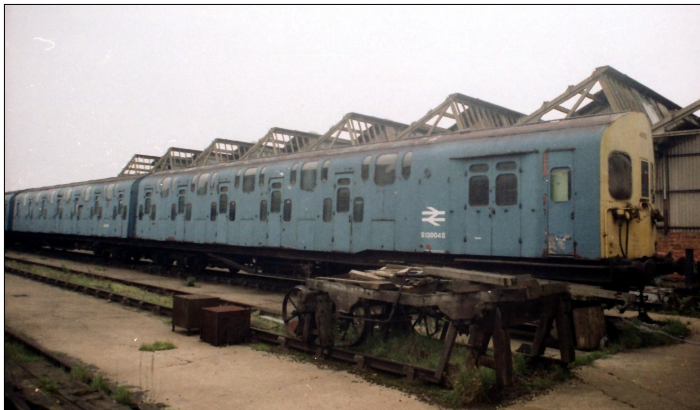
### 4DD unit at Ashford circa 1980

There were two four-car units designed by OVS Bulleid in 1949 and built at Lancing. They were experimental and were an attempt to overcome overcrowding on the South Eastern section of the Southern Region. Due to their larger loading gauge they were restricted to Charing Cross and London Bridge to Dartford and the Gravesend lines.

S13004S S13503 and S13003 featured in John's picture.
